Release note for Kit Com. official package named "KitCom.V01.17.28.zip"

- Charge point Firmware: V01.17.77
- Com. kit management Software: V01.17.27
- Com. kit web page Software: V01.17.09

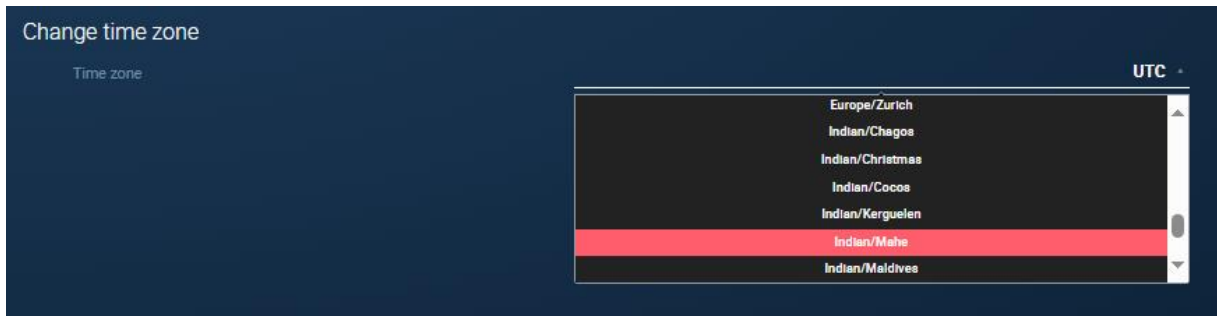
- [OCPP] Fix a bug: change availability to operative doesn't work after a hard reset.
- [DATETIME] Adding⁽¹⁾: Add the possibility to manually select the time zone on the web pages.

The time zone must be selected right after the update into the web pages of the communication kit in the window "information":
